Inspection Report

Property Address:
1234 Any Street
Anytown PA 23456

Mountain View Home Inspection Service

Date: 6/23/2020	Time: 12:00 PM	Report ID: 0623MB
Property: 1234 Any Street Anytown PA 23456	Customer: Joe and Jane Doe	Real Estate Professional: Some Agent Any Broker

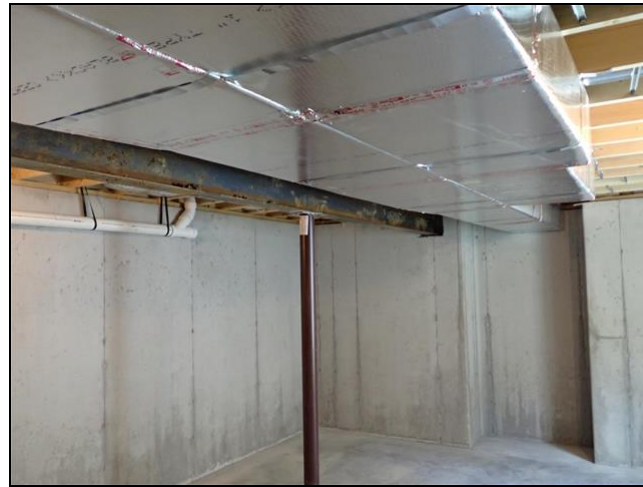
2.0 BASEMENT / FOUNDATION

The visible and accessible areas of the foundation appeared to be in serviceable condition at the time of the inspection.

Minor vertical cracks were observed in the foundation. This type and pattern of cracking is usually the result of concrete shrinkage as it cures. Shrinkage cracks are very common and are not normally a concern.

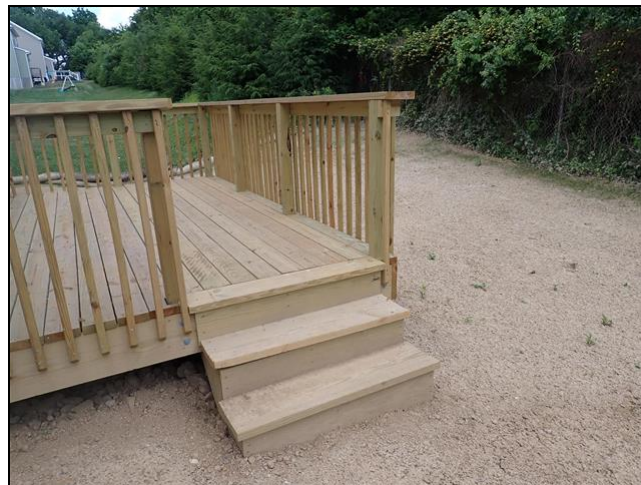
- (2) No railings were present at the rear deck steps. For increased safety, client should consider installation of a railing. Client should consult with a qualified contractor for information on current standards. Client should check with their homeowners insurance company for further information on requirements.
- (3) Steps were loose/warped at rear deck. Recommend repairs as needed. Client should check with their homeowners insurance company for further information on requirements.

(2) No railings were present at the rear deck steps. For increased safety, client should consider installation of a railing. Client should consult with a qualified contractor for information on current standards. Client should check with their homeowners insurance company for further information on requirements.

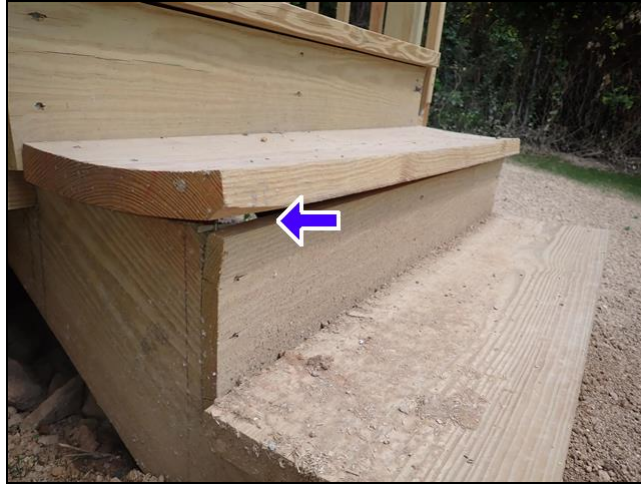
(3) Steps were loose/warped at rear deck. Recommend repairs as needed. Client should check with their homeowners insurance company for further information on requirements.

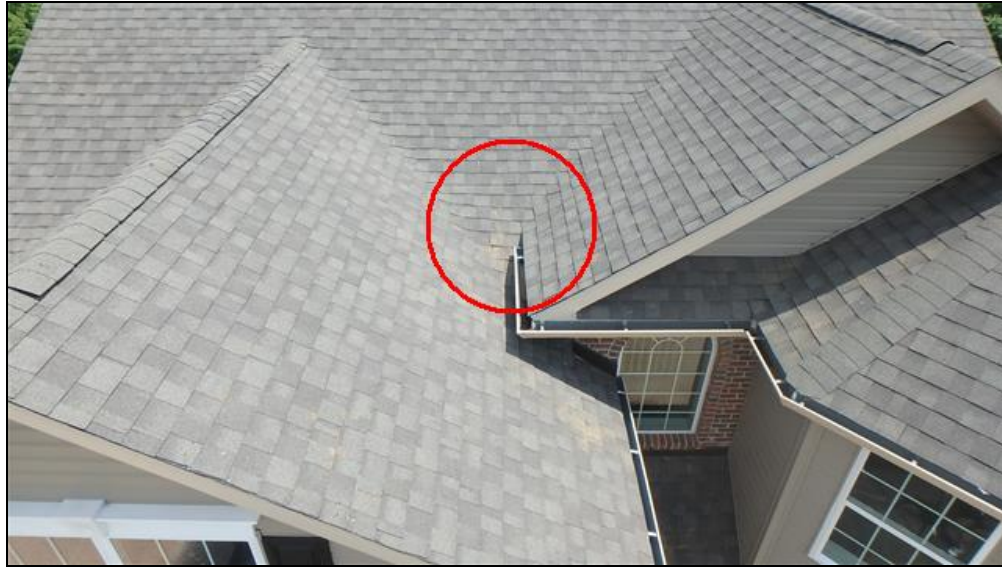
- (2) The roof area forms a valley with the slope terminating in a small area at front of house. Although this was the construction design, this area can become a high maintenance condition. Snow, ice, and water can accumulate and under some conditions, cause ice damming or water penetration in areas not readily visible or accessible. The conditions observed can increase the possibility that leakage has or may occur. Note: The condition of flashing and / or sheathing under the shingles or walls in this area could not be determined without destructive testing.

(2) The roof area forms a valley with the slope terminating in a small area at front of house. Although this was the construction design, this area can become a high maintenance condition. Snow, ice, and water can accumulate and under some conditions, cause ice damming or water penetration in areas not readily visible or accessible. The conditions observed can increase the possibility that leakage has or may occur. Note: The condition of flashing and / or sheathing under the shingles or walls in this area could not be determined without destructive testing.

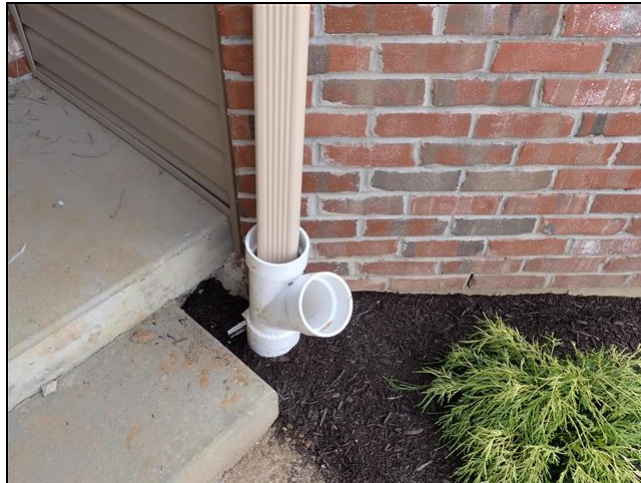
(2) The downspouts that discharge below grade level should be monitored. If they are ever suspected to be clogged or disconnected below grade, they should be redirected to discharge at least five (5) feet from the building. Foundation leakage adjacent to a downspout is an indication of a problem below grade.

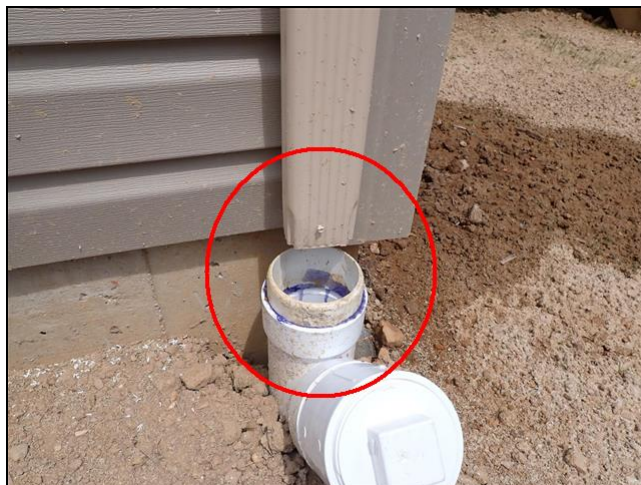
- (3) Recommend downspouts be extended to below grade discharge pipe to be properly routed away from the building for proper drainage. Water seepage into crawl spaces, basements and under foundations can be caused by inadequate removal of rainwater from the perimeter of the house.

(3) Recommend downspouts be extended to below grade discharge pipe to be properly routed away from the building for proper drainage. Water seepage into crawl spaces, basements and under foundations can be caused by inadequate removal of rainwater from the perimeter of the house.

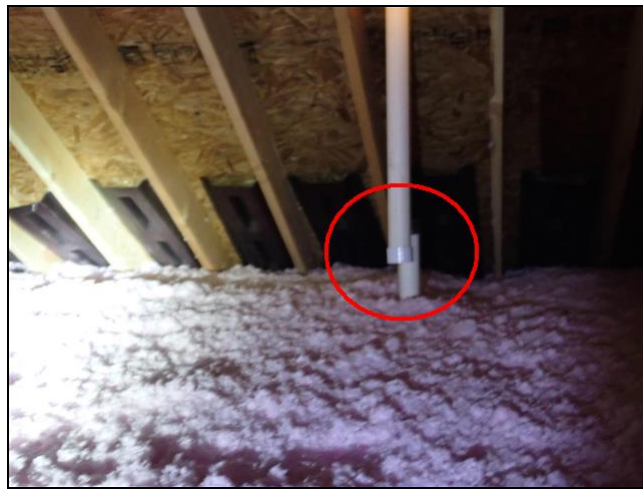
(2) The waste line plumbing vents did not terminate properly. Recommend further evaluation and repairs by a licensed plumber.

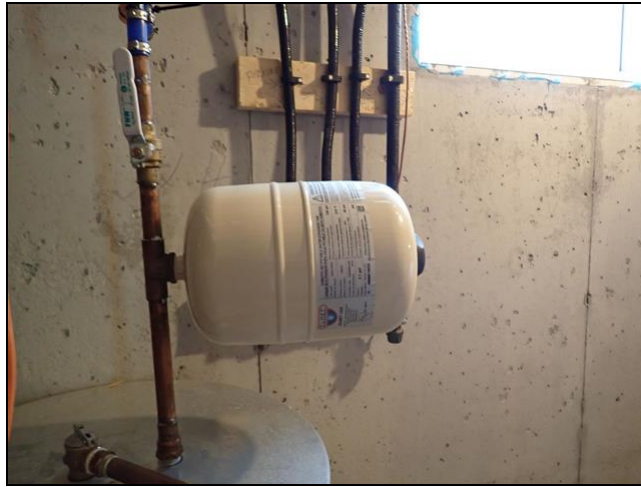
(2) The water heater expansion tank should be supported.

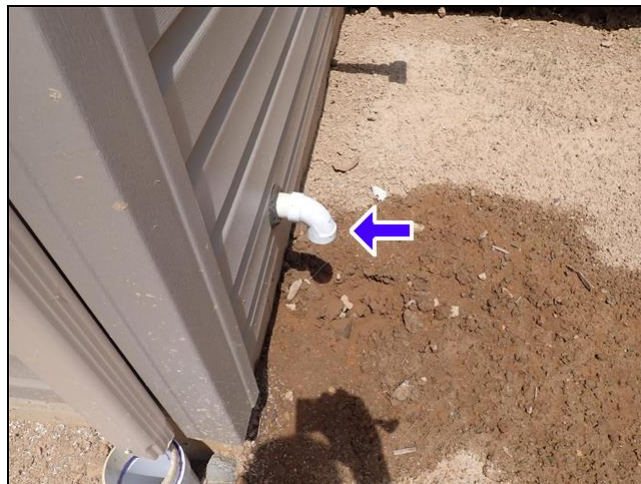
(2) Recommend extending sump pump discharge pipe further away from the house.

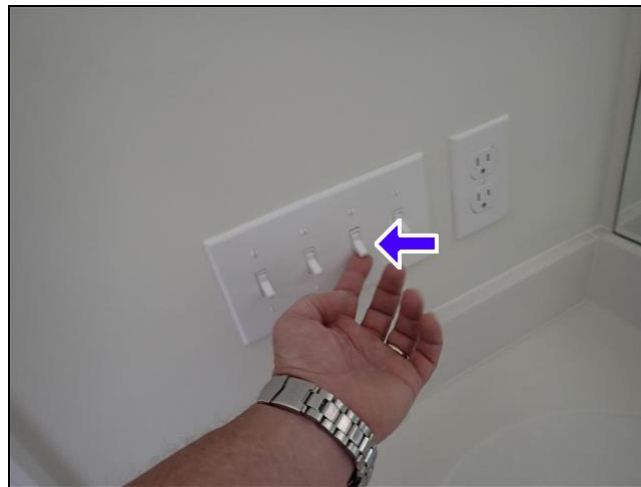
(3) Inspector was unable to determine purpose of a switch located at master bathroom. Client is advised to obtain information from seller or an electrician.

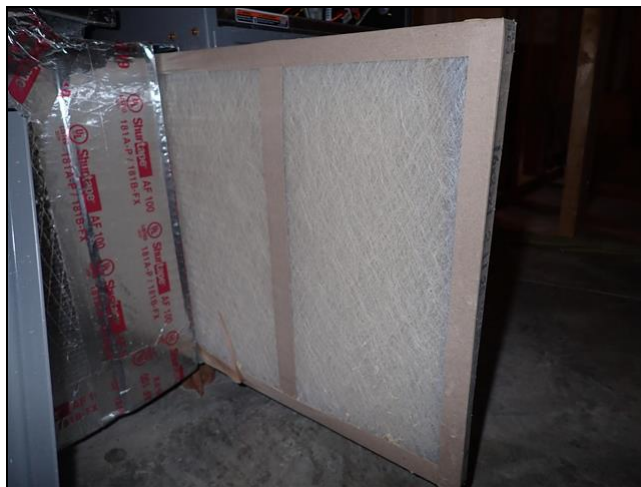
(1) The air filter was dirty. Suggest replacing as soon as possible.

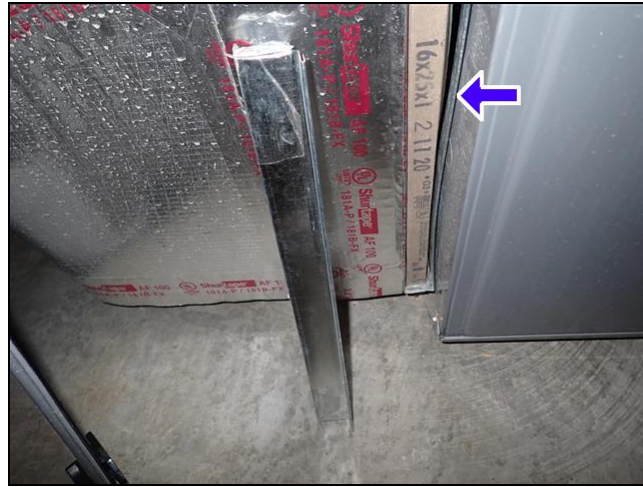
(2) The air filter slot was open at the return duct. This can draw unconditioned air into the heating system and increase the risk of carbon monoxide concern. Recommend a cover be installed over the filter insert slot. This should be a relatively minor modification for a qualified heating contractor.

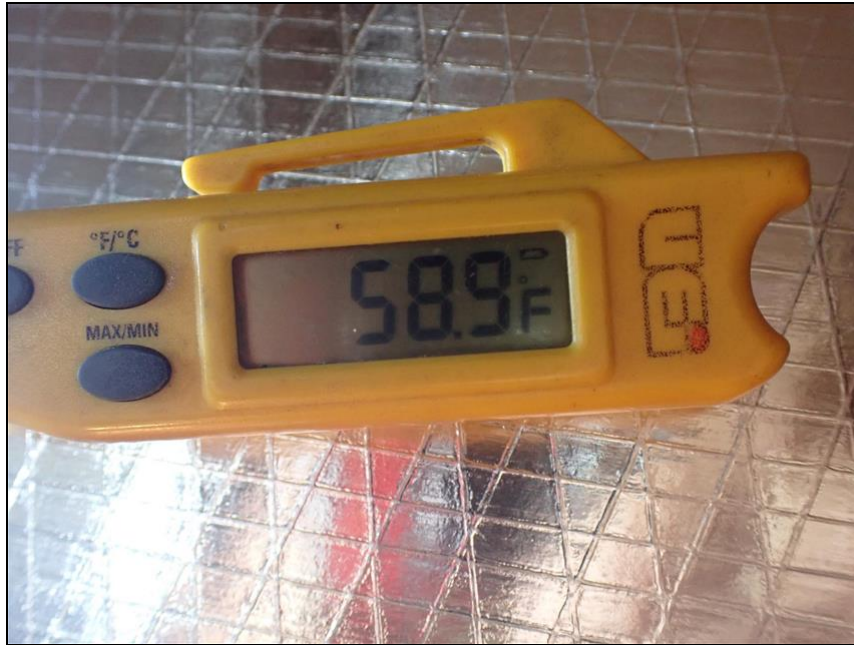
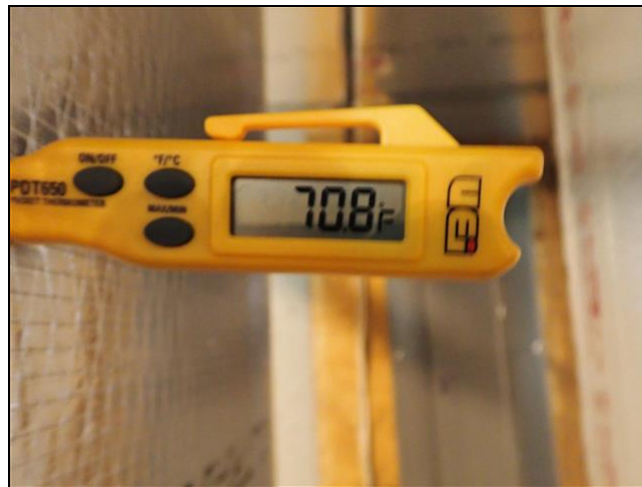
7.7 AIR CONDITIONING / HEAT PUMP TEMPERATURES

The temperature split between the supply and the return of the A/C system was less than the minimum of 15 degrees at the time of inspection. Recommend further evaluation by a licensed air conditioning contractor. The system may need cleaning, repair, additional refrigerant, or replacement.

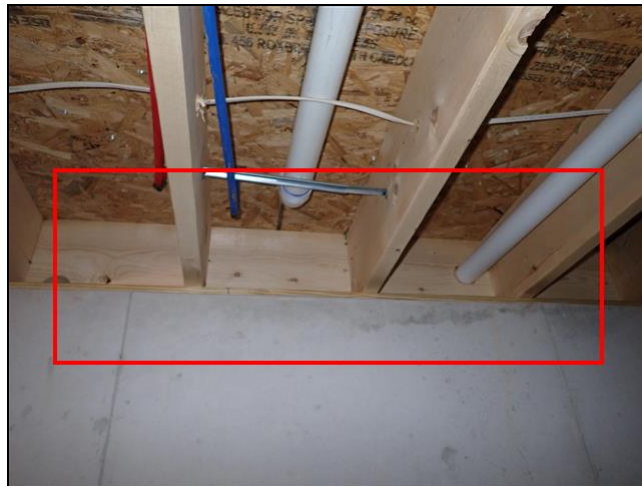
8.2 BASEMENT INSULATION

It would be wise to insulate the "rim joist" cavities around the perimeter of the basement.

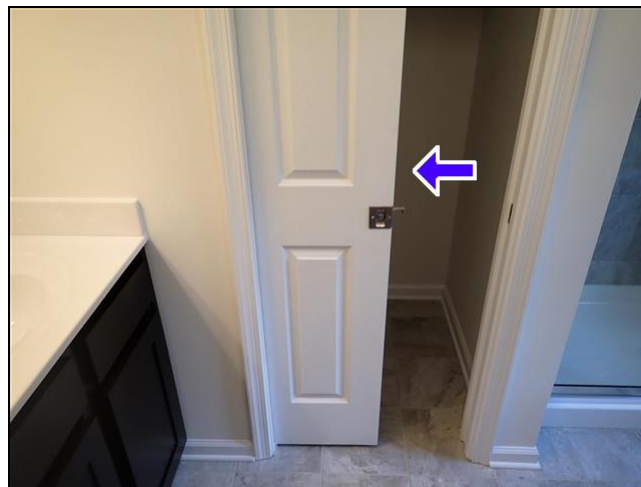
(2) The master bathroom water closet door was difficult to operate. Repairs and / or adjustments are recommended.

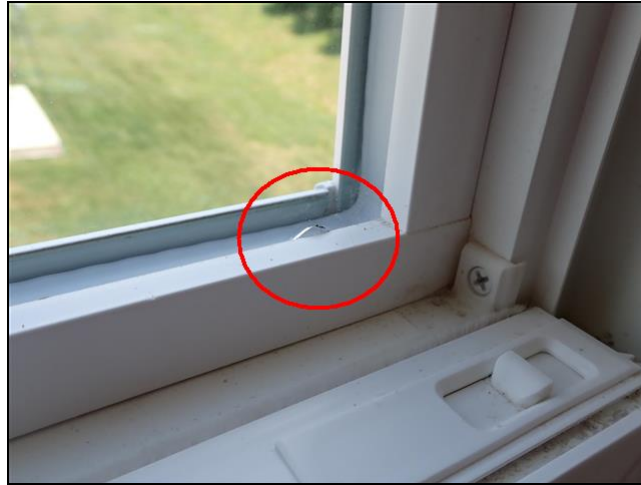
(3) Cracked glass window pane(s) were observed at rear left bedroom. Recommend repair as needed.

- (3) Cracked glass window pane(s) were observed at rear left bedroom. Recommend repair as needed.

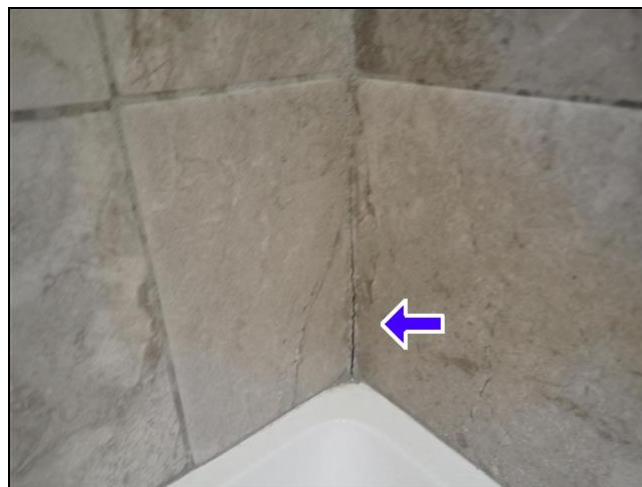
(2) Caulking and / or tile grout is needed at the master bathroom shower walls and / or floors.
