Inspection Report

Property Address:
1234 Any Street
Anytown PA 23456

Mountain View Home Inspection Service

Date: 6/23/2020	Time: 12:00 PM	Report ID: 0623MB
Property: 1234 Any Street Anytown PA 23456	Customer: Joe and Jane Doe	Real Estate Professional: Some Agent Any Broker

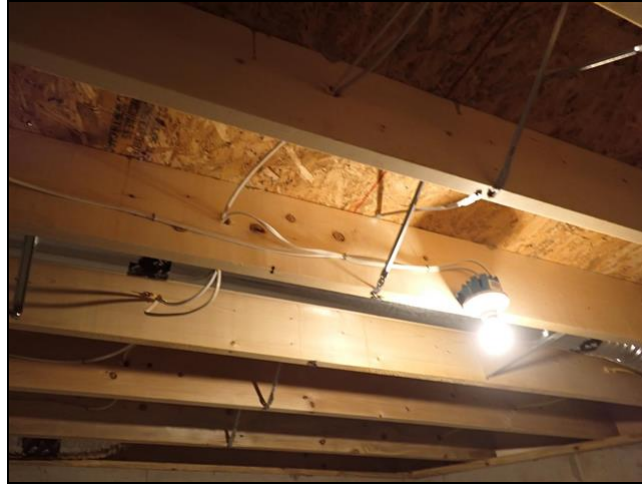
2.1 FRAMING

The visible and accessible areas of the wood framing system appeared to be in acceptable condition at the time of the inspection.

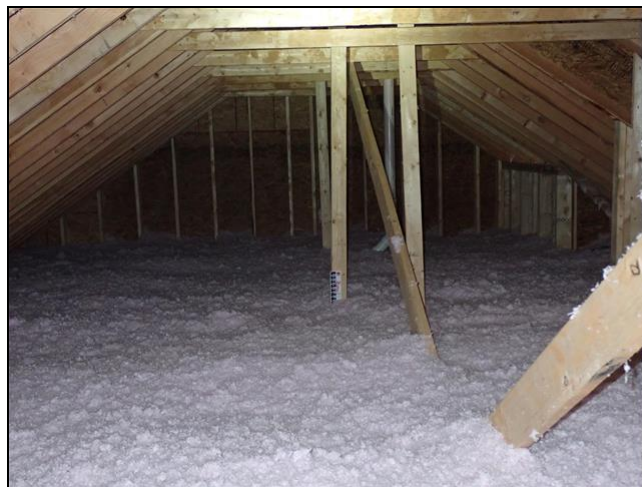
2.4 ROOF / ATTIC

The visible and accessible areas of the roof space/attic appeared to be in serviceable condition at the time of the inspection.

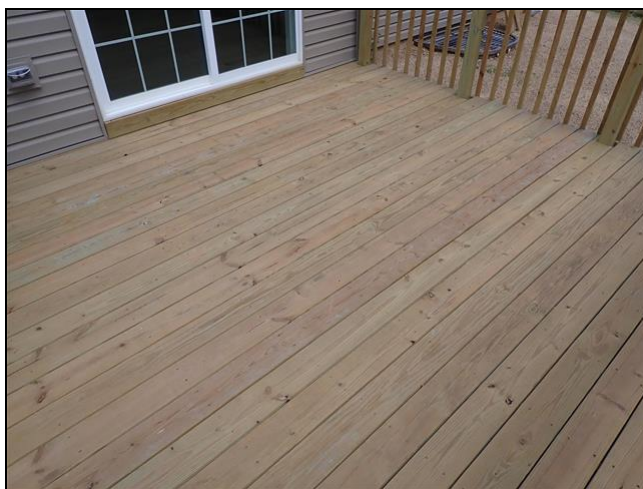
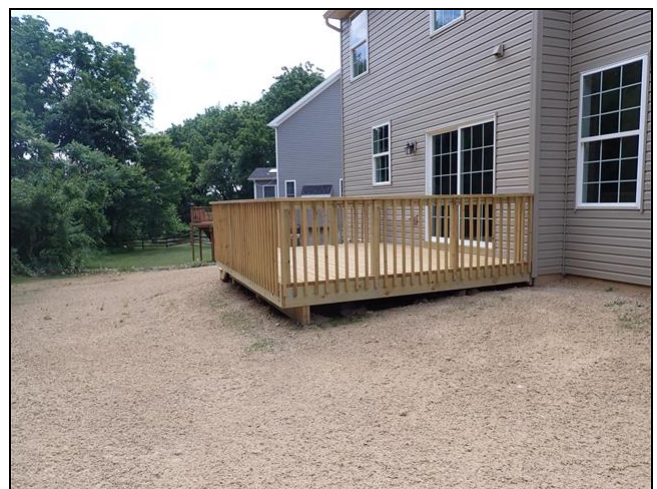
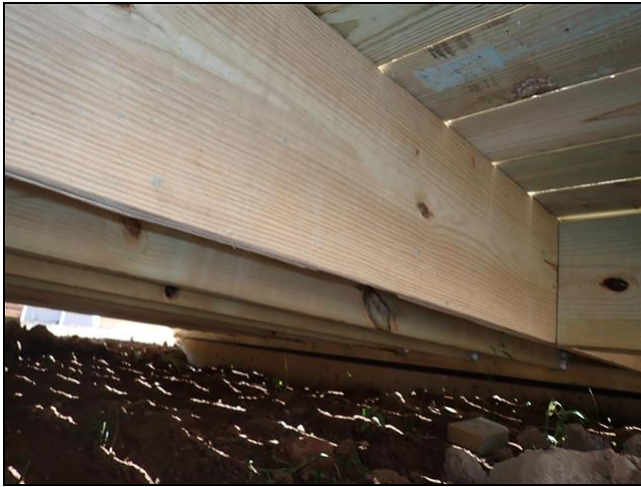
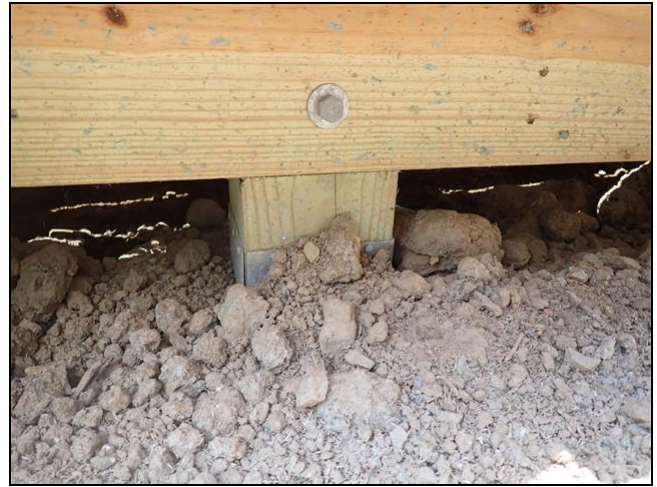
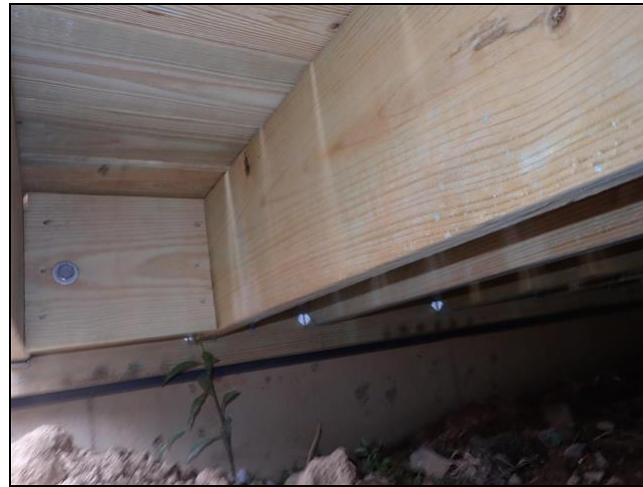
3.3 DECKS

The visible and accessible areas of the deck appeared to be in serviceable condition at the time of the inspection.

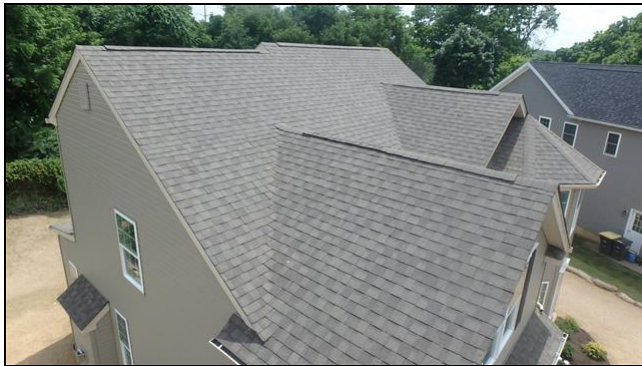
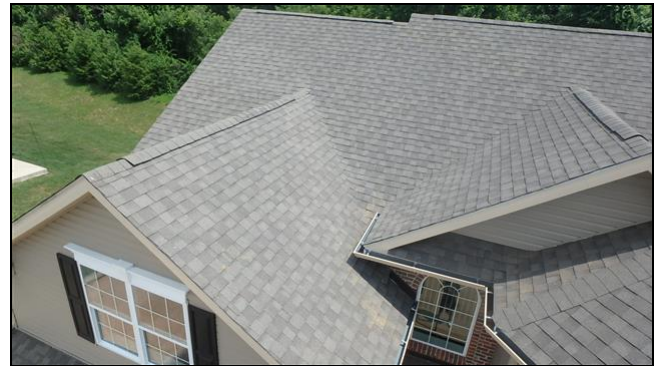
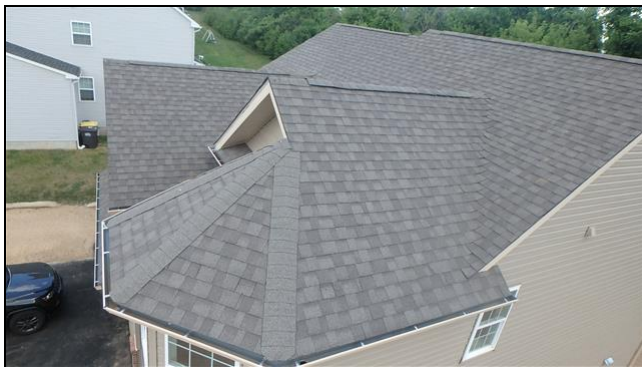
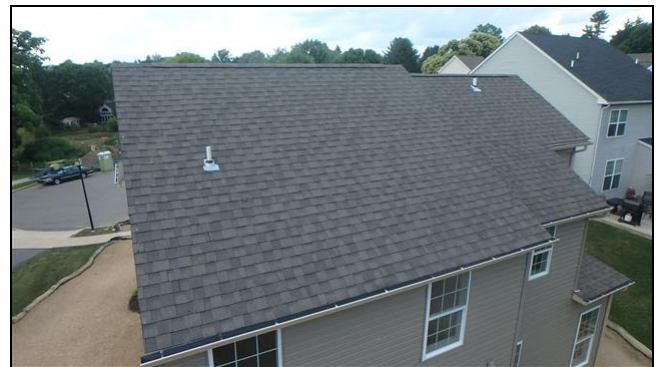
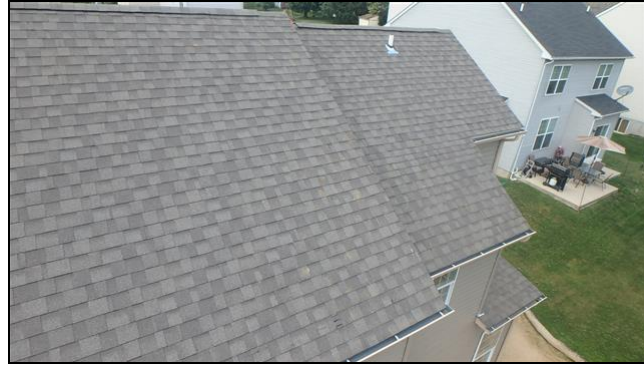
4.0 ROOF COVERING STATUS

(1) The roof covering shows normal wear for its age and appeared to be in acceptable condition at the time of the inspection.

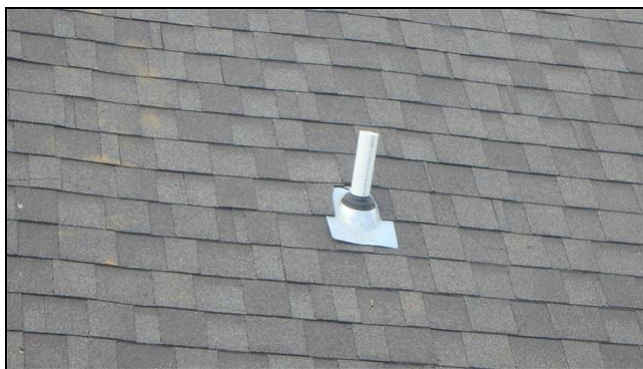
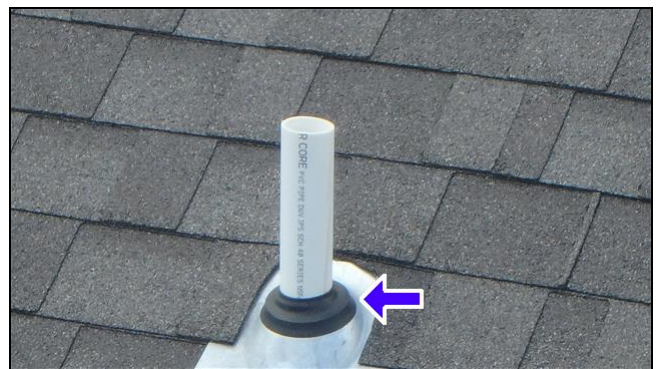
4.1 EXPOSED FLASHINGS

The exposed flashings appeared to be in acceptable condition at the time of inspection.

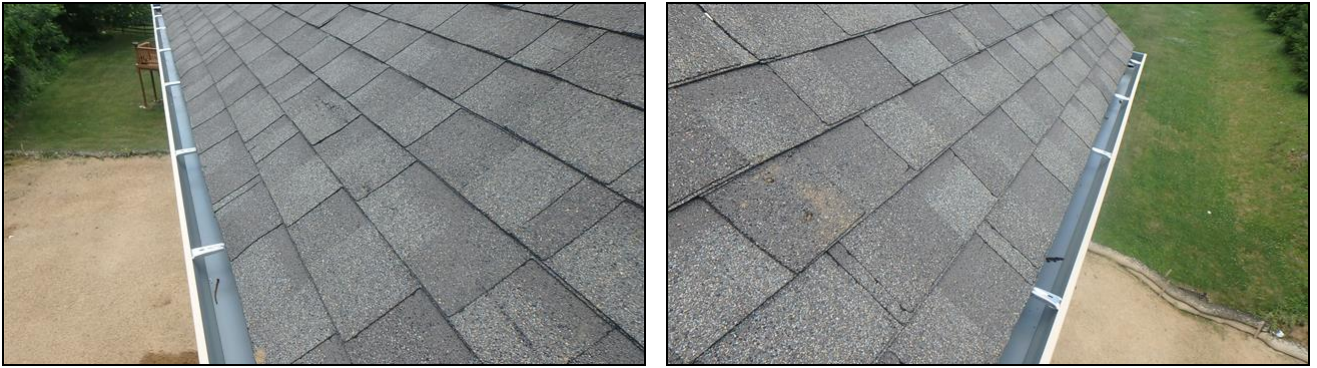
4.2 GUTTERS & DOWNSPOUTS

(1) The gutter system appeared to be in acceptable condition at the time of the inspection.

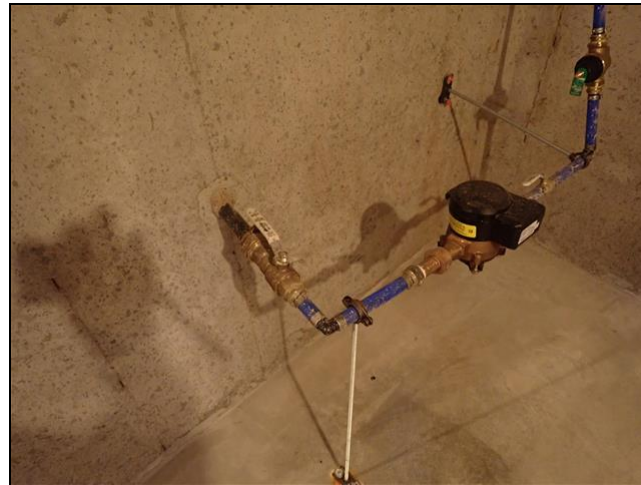
5.0 MAIN WATER LINE

The visible portion of the main pipe and valve appeared to be in serviceable condition at the time of the inspection.

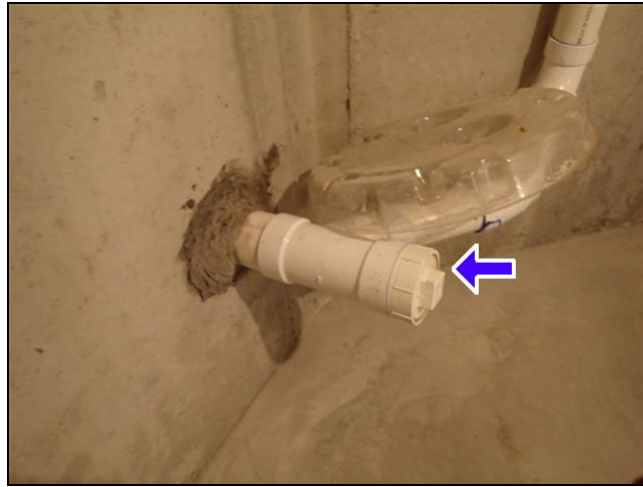
5.2 PLUMBING WASTE LINES

(1) The visible portions of the waste lines appeared to be in acceptable condition at the time of inspection. All of the waste lines were not fully visible or accessible at the time of the inspection.

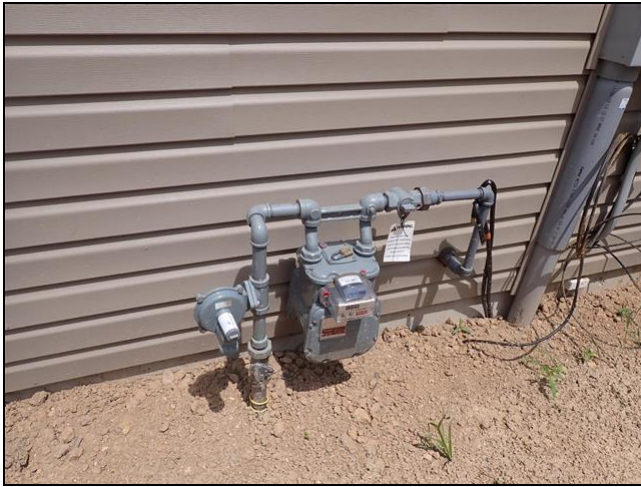
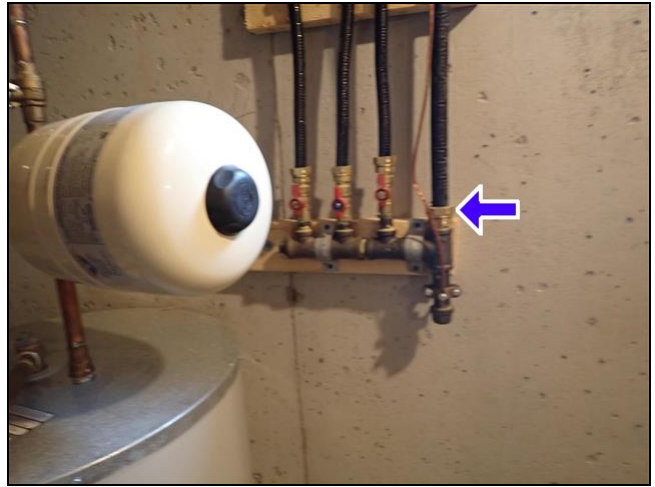
5.4 FUEL SYSTEM

The visible portions of the gas meter and fuel lines appeared to be in acceptable condition at the time of inspection. All of the fuel lines were not fully visible or accessible at the time of the inspection.

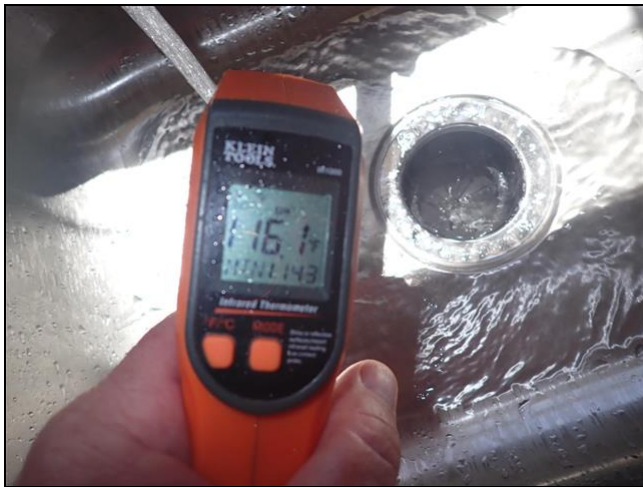
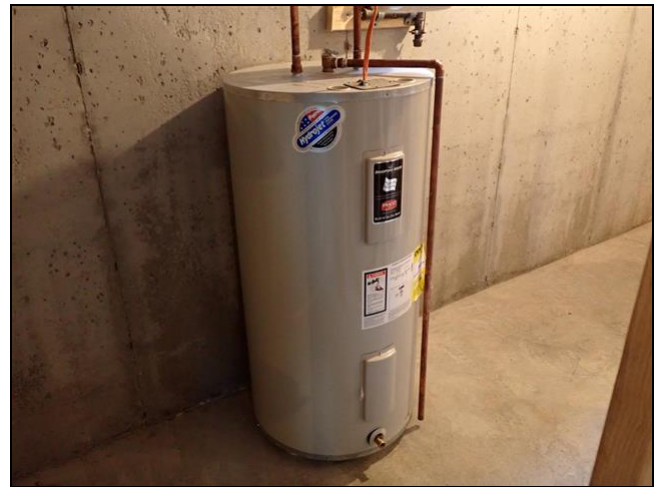
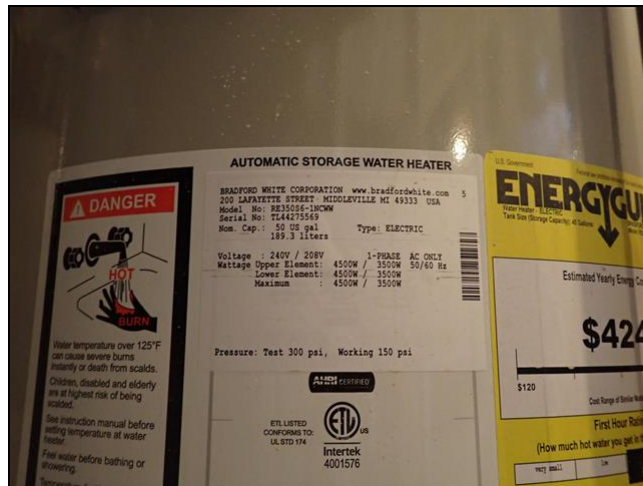
5.5 WATER HEATER

MFD 2019

(1) The electric water heater was operable at the time of inspection. This does not however guarantee future performance, operation, or condition. TPR (temperature pressure relief) safety valve was present on the tank. The water heater wiring appeared to be in serviceable condition at the time of the inspection.

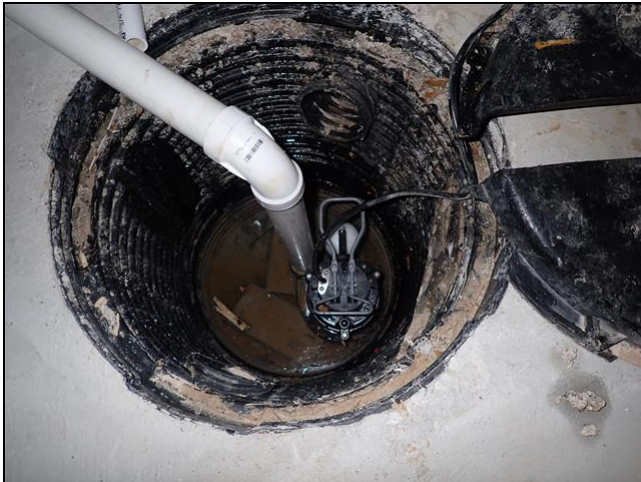
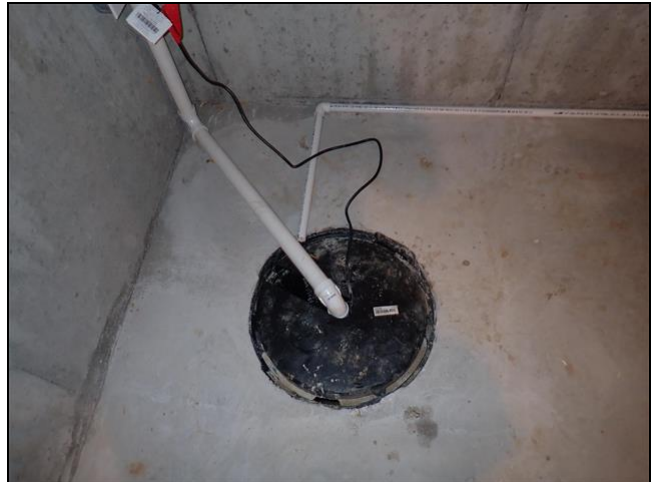
5.6 SUMP PUMP

(1) A sump pump was present. The sump pump operated when tested at the time of the inspection. This does not however guarantee future conditions or operation. Inspector does not trace or locate discharge termination point of drain line. Client should obtain disclosure / history information from the seller regarding any previous water penetration.

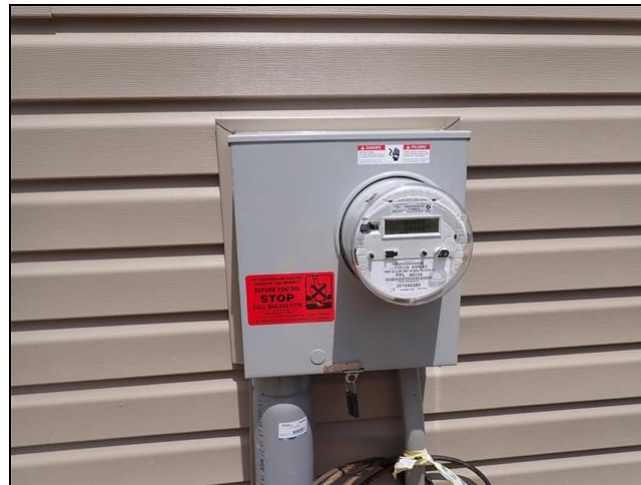
6.0 ELECTRICAL - SERVICE

The main service entry appeared to be in serviceable condition at the time of inspection.

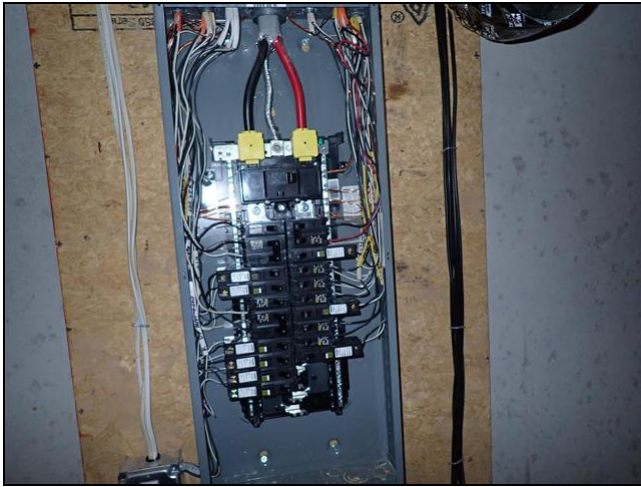
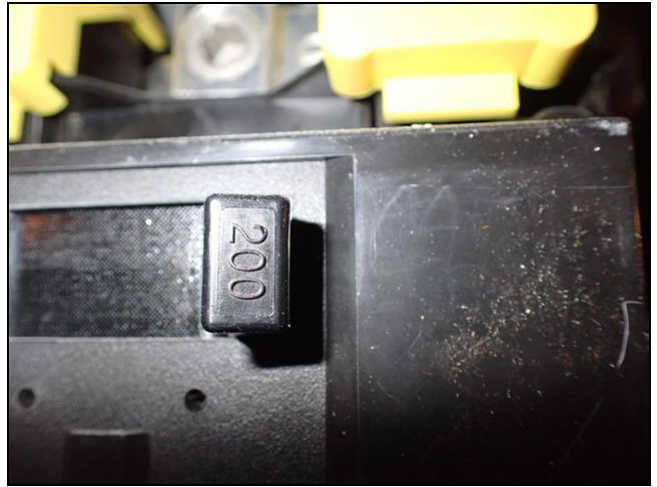
6.1 ELECTRICAL / MAIN PANEL

The main panel appeared to be in serviceable condition at the time of the inspection, except if noted otherwise below.

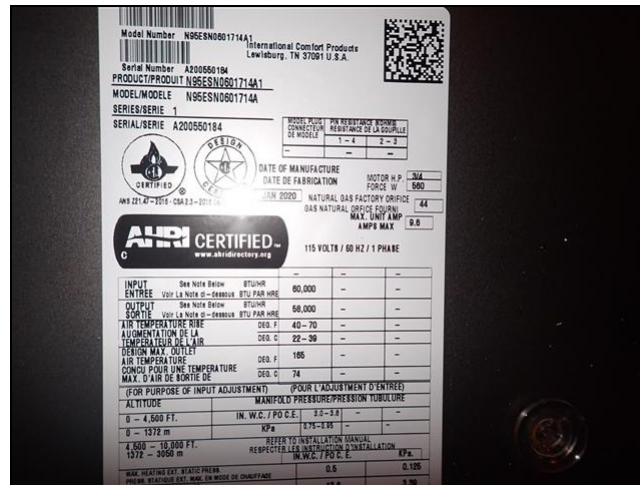
7.0 HEATING SYSTEM - CONDITION

MFD 2020

The heating system was operational at time of inspection. This may not, however, be an indication of future operation or condition.

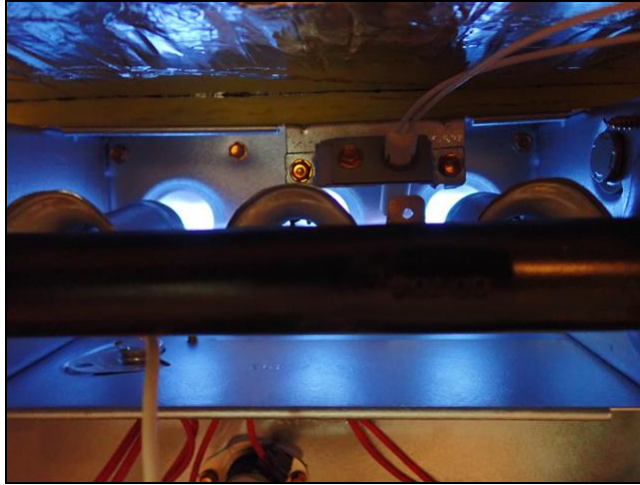
7.2 HEATING SYSTEM - BURNERS

The visible and readily accessible areas of the burner flames appeared to be typical at the time of inspection.

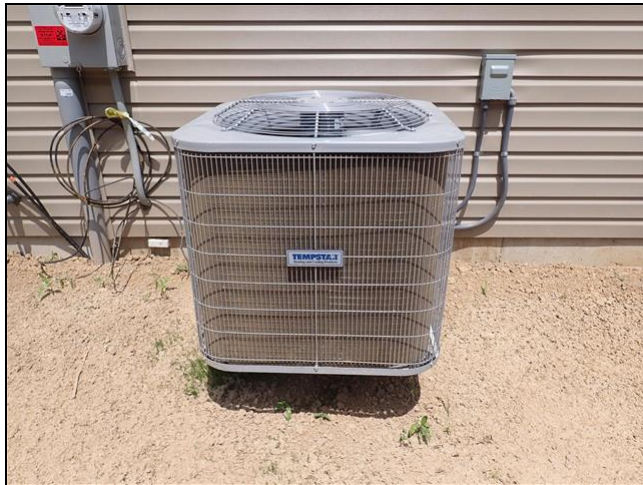
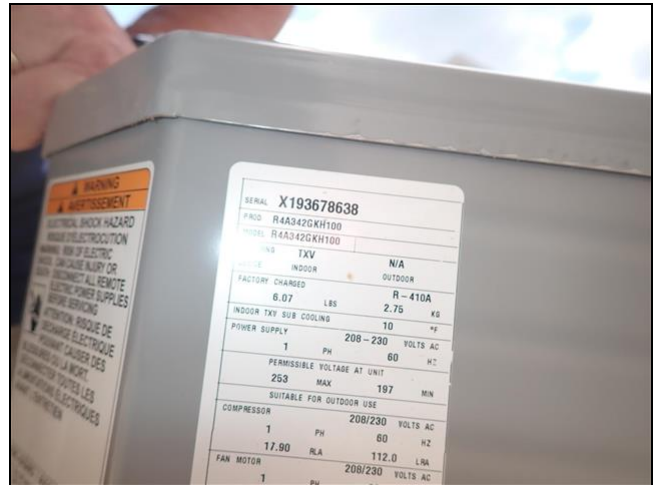
7.6 AIR CONDITIONING/HEAT PUMP - CONDITION

MFD 2019

The air conditioning system was operational at the time of inspection. This may not however be an indication of future conditions. Client is advised to run A/C at final walk through if conditions permit. Exterior temperatures should be above 65F before operating.

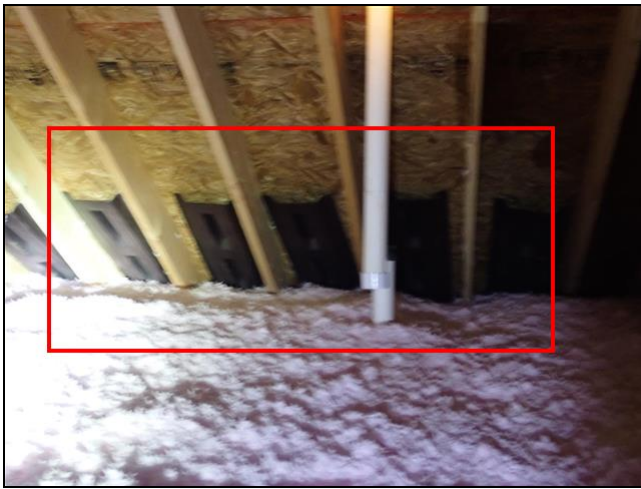
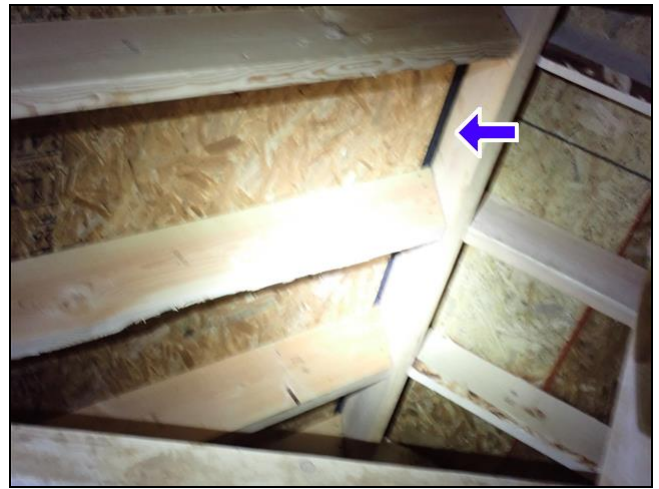
8.0 ATTIC VENTILATION

The visible and accessible portions of the attic/roof ventilation appeared to be in serviceable condition at the time of the inspection.

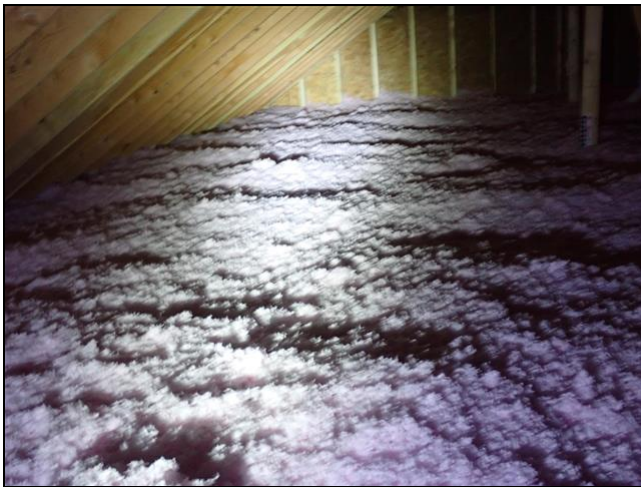
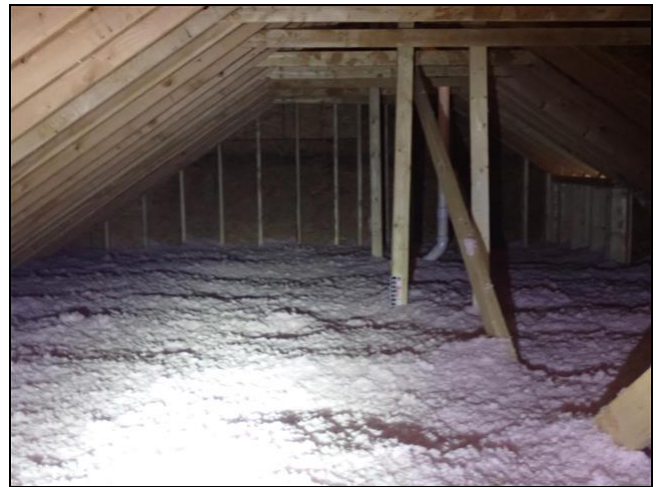
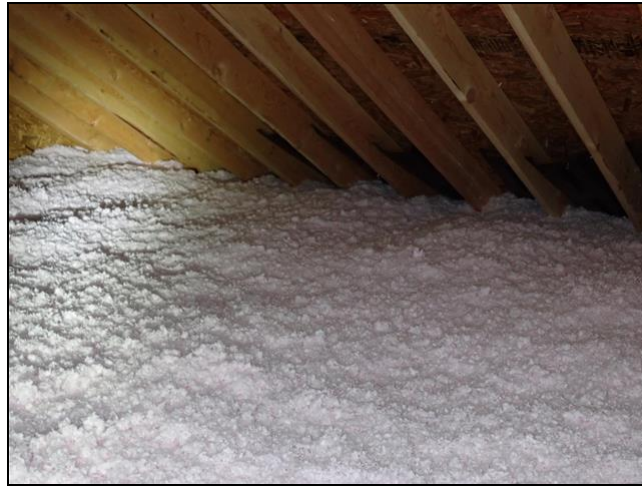
8.1 ATTIC - INSULATION

Insulation is typical for the age and style of house.

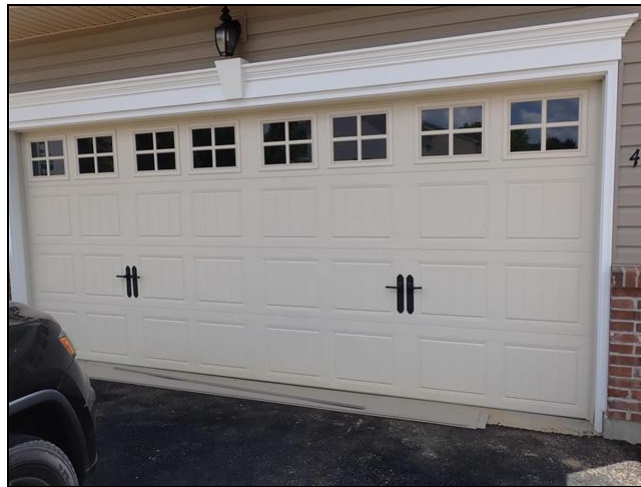
9.0 GARAGE DOOR(S) CONDITION

(1) The vehicle door(s) appeared to be in serviceable condition at the time of the inspection.

(2) Coil type springs were present.

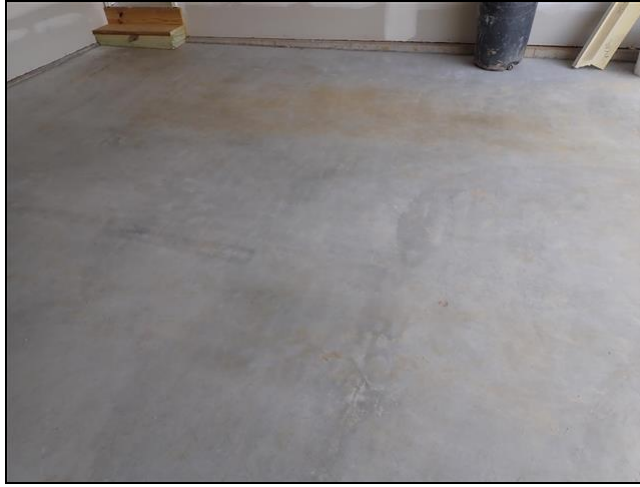
9.3 GARAGE FLOOR

The garage floor appeared to be in serviceable condition at the time of the inspection.

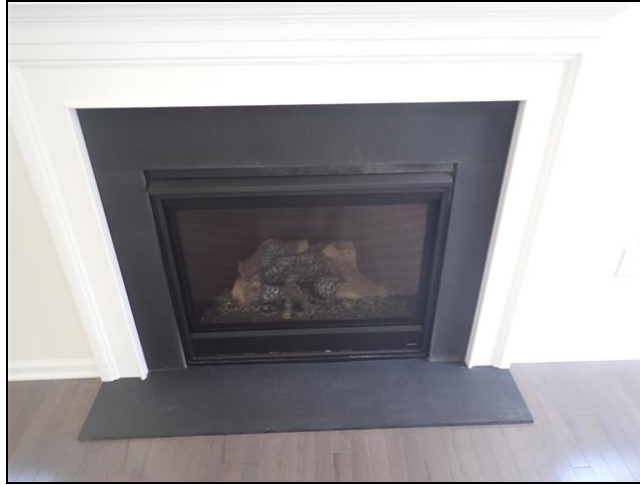
10.9 FIREPLACE / WOOD STOVES

The gas fireplace was operational at time of inspection. This may not, however, be an indication of future operation or condition.

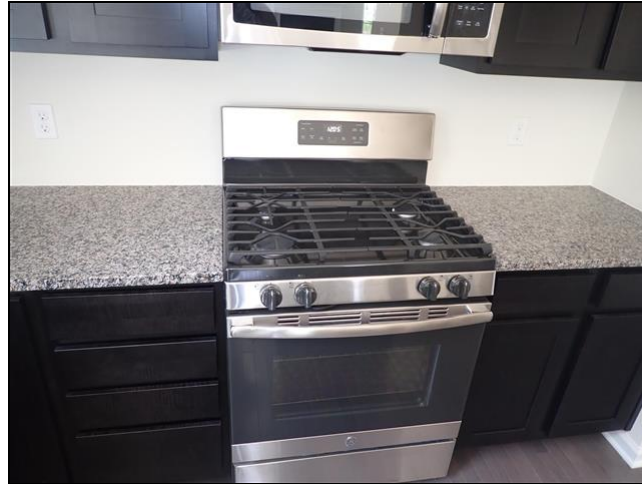
11.1 RANGE/COOK TOP AND OVEN

The range was operational at the time of the inspection. This does not however guarantee future conditions after the time of inspection.

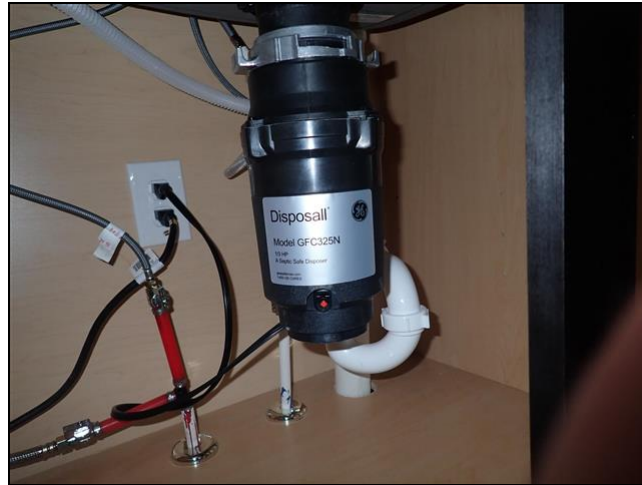
11.3 DISPOSAL

The sink disposal was operable at the time of the inspection. Client should consult a licensed plumber, manufacturer, or disposal supply company for information on proper usage and safety related concerns.

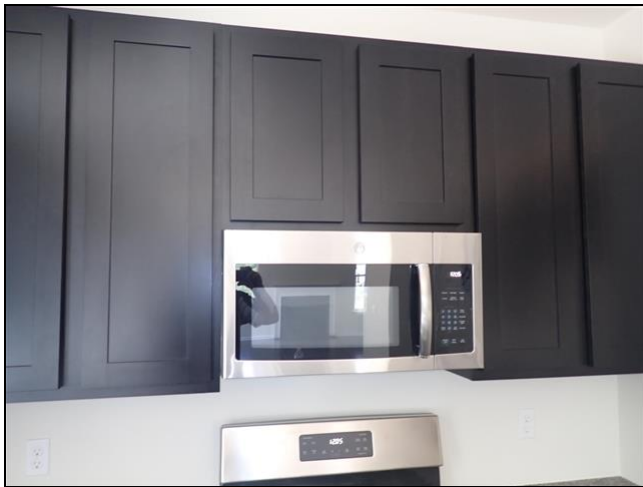
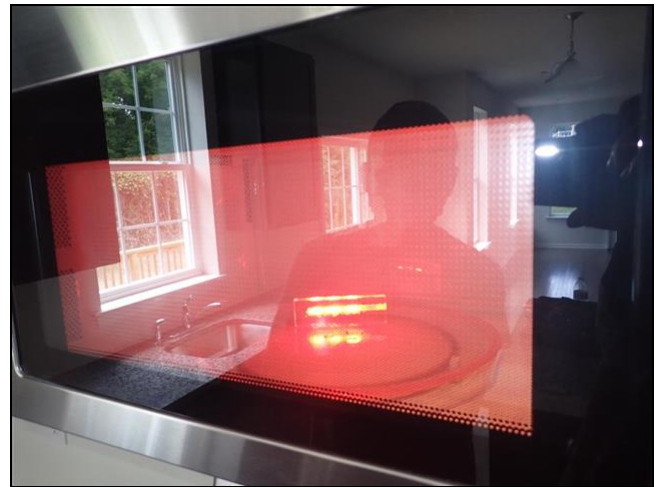
11.4 MICROWAVE

(1) The microwave was operational at the time of inspection, this does not however guarantee future conditions. Testing of leakage or efficiency of cooking operation is not part of this inspection.
